Hydro Review: Experiences with Using HOD UV Technology to Control Mussel Fouling

By Leonard Willett

Parker Dam: A close look

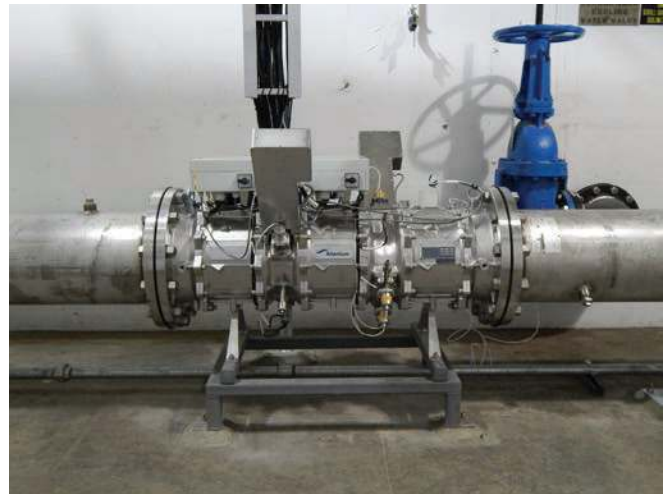
The Hydro-Optic UV system installed at Parker Dam.

In December 2015, two HOD UV systems were installed at Parker Dam. Each UV system (Model RZB300-12 with DPM or deposit protection mechanism) accommodates a flow rate of 454 cubic meters per hour (1,600 gpm) for water quality conditions with UV transmittance (UVT) as low as 85%. UVT is an indicator of water quality and designates the percentage of UV light that passes through the water. The remaining three HOD UV systems were installed and commissioned in the spring of 2016.

The medium-pressure HOD UV systems were supplied with a deposit control mechanism, percent UVT monitor, UV dose monitor and flow switch. To confirm water was flowing, limit switches on cooling water valves were used instead of installing a flow meter on each system. As a result, some of the features of the HOD UV system to pace flow and control dose were not used.

Due to space constraints, the HOD UV units could not be installed immediately after the strainer of the raw water for the cooling water supply. To address the issue, the 14-inch piping was extended and looped back, providing the additional footprint needed to accommodate each UV system. The UV systems were placed horizontally with adequate spacing for maintenance (30 inches on each side for ease of UV bulb removal and located 3 to 4 feet above the floor).

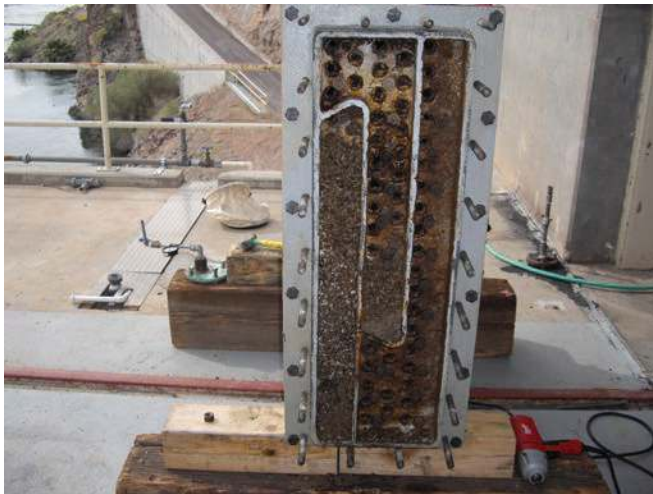
Before photo of Parker Dam heat exchangers, with significant scaling

Since installation, the HOD UV technology has required minimal oversight by Parker Dam staff. Staff members perform a daily check to confirm system operation. In terms of system maintenance, the only change has been to the clean-in-place (CIP) schedule. Due to the hardness of incoming water, a higher frequency CIP schedule was required.

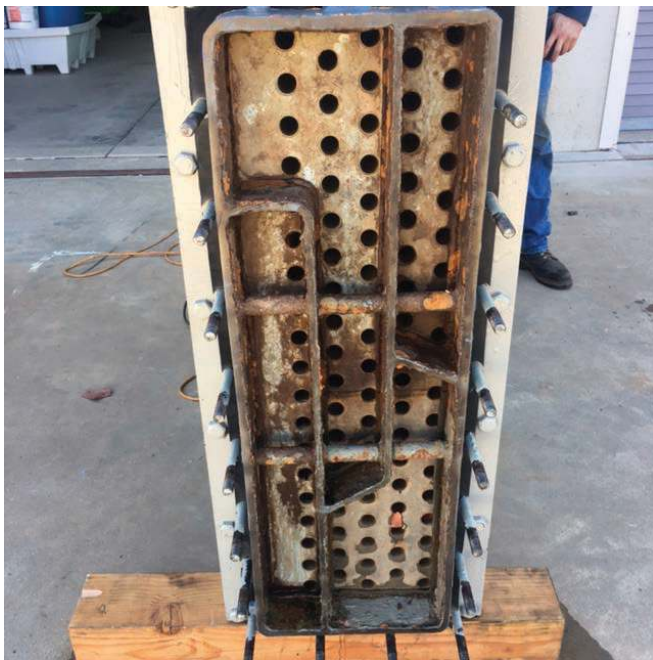
After photo of heat exchangers, with scaling noticeably reduced.

Scaling on the heat exchangers was noticeably reduced with the use of the technology.

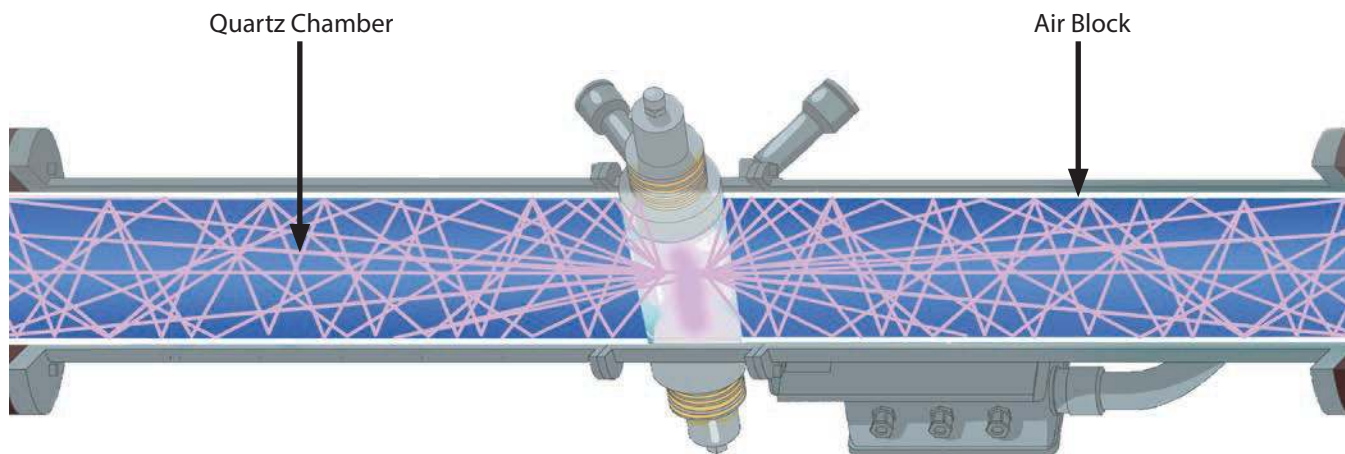
Hydro-Optic UV Lamp and Chamber with Total Internal Reflection

The HOD UV system uses a total internal reflection-based design that -- when coupled with the comprehensive monitoring of such critical parameters as flow rate, UV lamp intensity and ultraviolet transmission percentage -- allows the system to achieve and maintain the specified UV dose. A UV dose of less than 100 millijoule per square centimeter (mJ/cm²) was used at Parker Dam to achieve 99% inhibition of quagga mussel veligers settling downstream of the HOD UV systems.
